# Blowout During Fracture Stimulation Operations

## Case Study

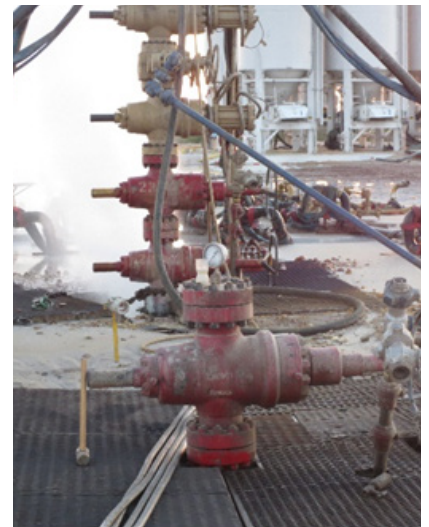
This incident occurred while fracturing operations were ongoing. It was reported to be on stage 19 of a planned 24 stages. The failure occurred on the wing valve on the tubing head where it flanges up to the wellhead body. This left no mechanism to isolate the flow and the returning water and sand mixture quickly cut the valve and wellhead body.

- There was a full frac spread on location along with electric line equipment and live perforating guns.
- Significant water run-off was already occurring on location.
- There was another wellhead adjacent to the subject well.
- Wellhead body damage was present from the exiting flow.

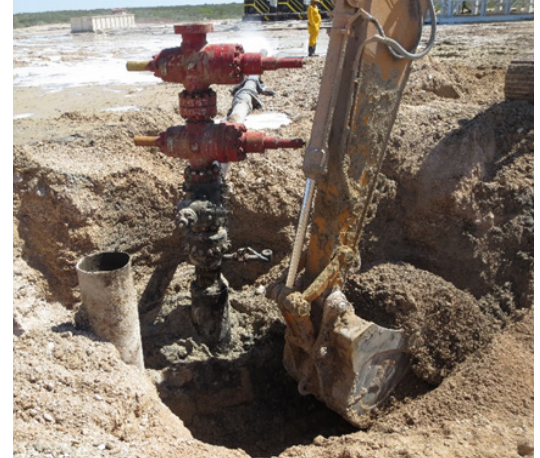
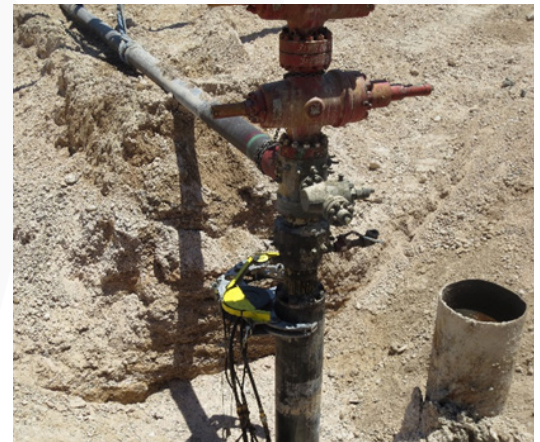
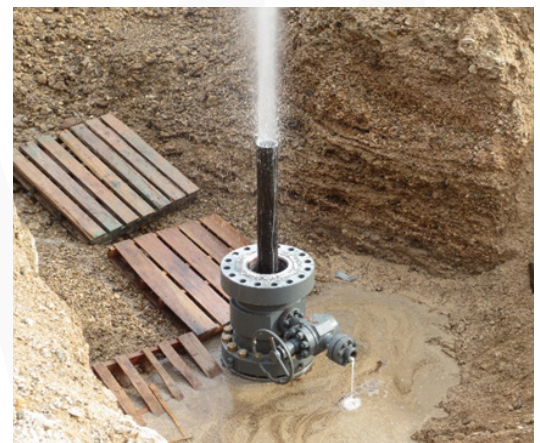
The water flow on location was controlled by digging a trench to the reserve pit, where it could be captured and hauled off as required. This also allowed well control personnel to assess the actual damage to the wellhead by connecting the cellar to the trench. After confirmation that the wellhead was compromised and unusable, the area was excavated to allow it to be removed. This excavation was aided by a diversion technique using a joint of casing. This diversion allowed well control personnel to work heavy equipment at the well while minimizing any risk from the well flow.

Upon excavation of the area around the wellhead, plans were implemented to make a cut to remove it from the casing. In the past, an Abrasive Jet Cutter (AJC) was the preferred method for wellhead removal during a blowout. There are still many applications where this is the only viable method. However, in this case, WWC personnel offered the option to utilize a Diamond Wire Saw (DWS) to make the cut. This involved no real additional support equipment outside of the cutter itself and the hydraulic power unit. The AJC requires sand and pumping equipment, along with an Athey wagon for the typical deployment.

The DWS was utilized and enhanced the speed of the intervention operations. This cut was made successfully through 2 casing strings and the old wellhead was safely removed. The casing strings were then cut again at the appropriate location to facilitate the new wellhead installation. A slip lock wellhead was selected for this application to eliminate any hot work at the wellhead.
