# Inland Water Blowout and Fire Case Study

# Inland Water Blowout and Fire

## Case Study

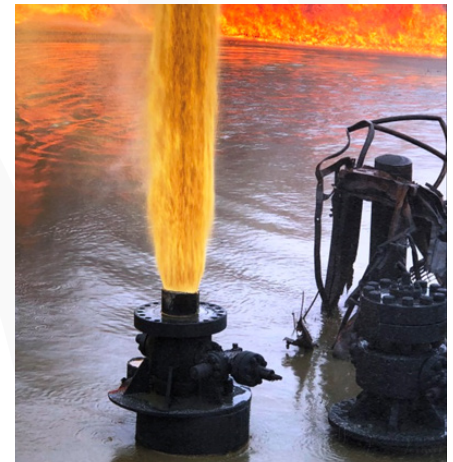
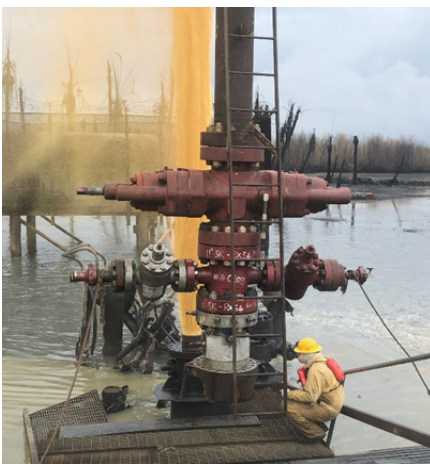
At the wellhead, all existing studs were removed and the flange was hot-bolted in preparation for removal. A flow tube assembly was modified with pad eyes around the tube for chain binder attachment points. A conventional Athey wagon moved this flow tube over the blowout and allowed WWC to drop additional studs with modified pad eyes to provide the second attachment point. With the chain binders now attached, the Athey wagon was able to pick up on the flange and remove from the wellhead. The wellhead upper flange was now inspected and approved for landing a capping stack.
