Blowout During a Completion Operation with a Snubbing Unit

Case Study

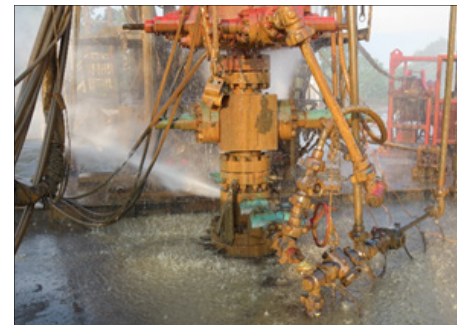
This incident occurred while drilling out plugs in a post-fracture stage of the completion. The cause was suspected to be movement of the wellhead, BOP and snubbing unit while drilling out the plugs. This instability at the wellhead was noted upon arrival and suspected to be the primary reason for the wellhead component failure. During the drilling operations, the wellhead and snubbing equipment was reported to have demonstrated slight freedom of movement. The tubing spool wing valve was tied into a flow line to the gas production equipment on location. This line was buried and did not move along with the wellhead components, placing stress on the connection at the wellhead. The flanged connection at the tubing spool wing valve and the wellhead ultimately failed and began to leak. The leak quickly intensified, and the location was evacuated.

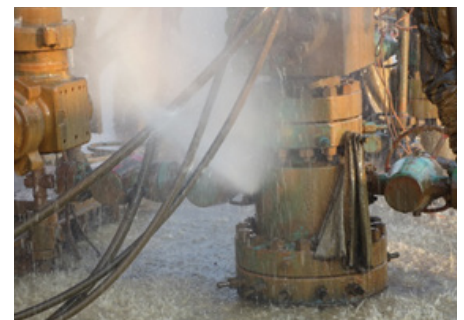
The initial site assessment noted the following challenges:

- A workover rig and rig-assist snubbing unit were installed and would need to be removed if the well could not be killed initially.
- There was tubing through the snubbing unit and BOPs and a power swivel hanging in the rig elevators further complicating the process of removing these assets.

- The failure at the tubing spool body dictated that the tubing spool would have to be removed to secure the well.
- There were 3 additional wells in close proximity to the subject well with the potential for escalation into a multiple well event.

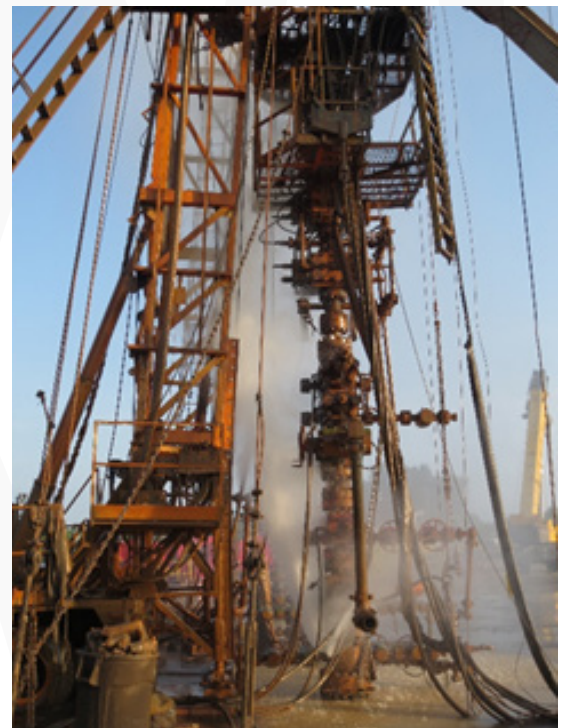
The plan then moved towards the removal of the failed tubing spool. This would require the removal of the workover rig, snubbing unit, BOP equipment and frac valves. Along with direct actions to the subject well, the adjacent wells had protective cages installed to limit possible escalation. These were fabricated by the client and installed over the 3 additional wells on the pad.

The tubing was cut in the snubbing basket to allow the power swivel to be removed. The rig blocks were secured to the derrick and the tubing board was removed with a crane. The workover rig hydraulic system was plumbed into an auxiliary source and the derrick was scoped in and laid down, allowing the rig to be removed from the well site. With the rig removed, operations proceeded to the next phase.

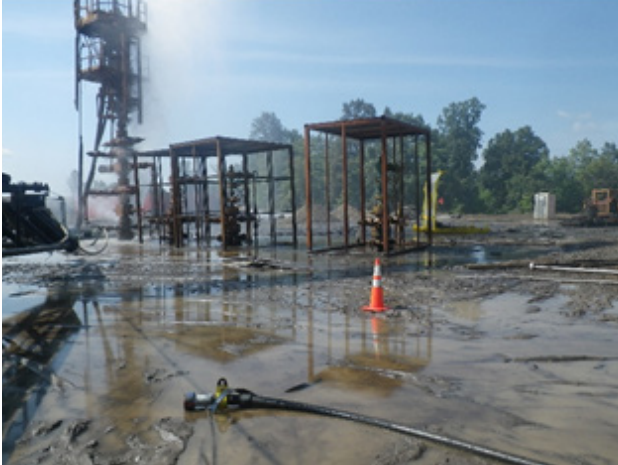
The next phase of the intervention was to make an abrasive jet cut on the lower frac valve. The snubbing unit, BOP equipment and frac valves would all be removed with the crane upon completion of the cut. The crane was tied onto the snubbing unit lifting bridle and the necessary pumping equipment was rigged up and tested for the abrasive cut. The WWC Abrasive Jet Cutter (AJC) was installed on an Athey wagon and the cut was completed without issue. The snubbing unit and additional components on the stack were removed leaving the tubing spool and bottom flange from the lower frac valve. The crane was tied to the tubing spool and the spool was removed from the casing spool – thus removing the failed component from the wellhead. The capping BOP could now be installed on the casing spool for securing the well.

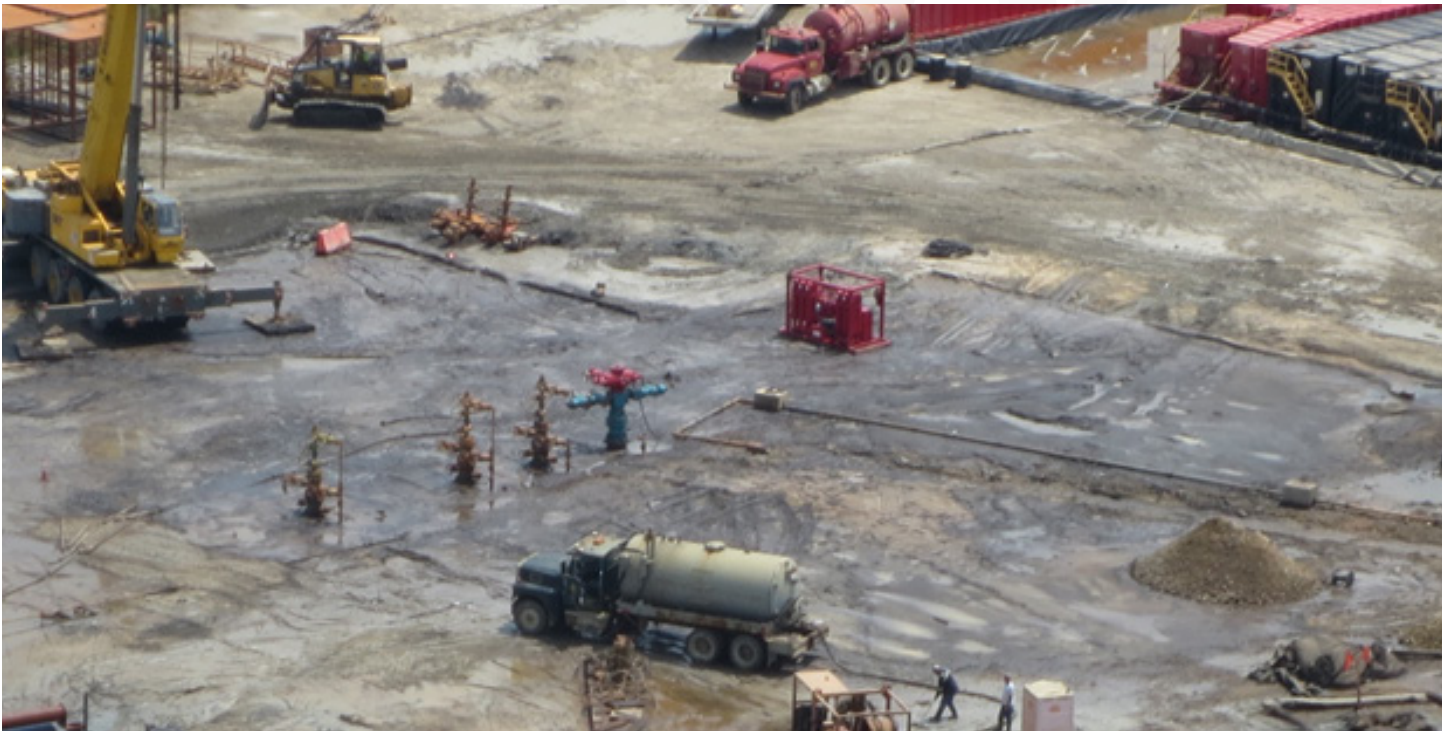
The capping stack for this operation was a single blind ram. The well was planned to be shut-in and would not require any diversion as the previous failed tubing spool was now removed, and the original wellhead that was installed was unaffected by the event. The capping BOP was landed on the casing spool with no issues and closed, securing the flow from the well. The client began planning the wellbore recovery operations.
